April -June 2015 Edition

HAZMAT IS NEVER ON THE BERTHING BILL

FLASH

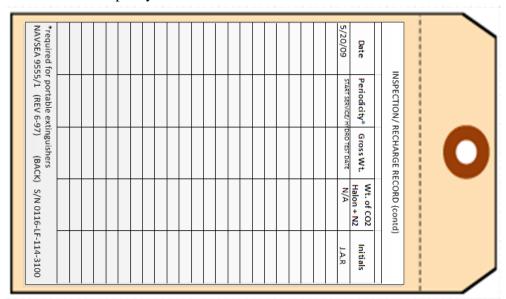
In the event that a casualty occurs onboard your ship, it is important that your damage control gear is in the best condition possible. Attention to detail and procedural compliance is how you get it there. Some discrepancies I find while performing my assessments would be considered minor in the grand scheme of things, but they say a lot about the attention to detail given to following the MRC properly. Take filling out an AFFF tag for example: it doesn't affect the operation of the extinguisher, but it does tell how much attention is paid to the MRC when doing the maintenance on the extinguisher. If you are performing that maintenance, take the time to look at the MRC and the figure that shows how the back of the tag is supposed to look. The top line should be the start service/hydro test date. This is an example of what the top line on the back of the AFFF extinguisher tag should look like. If it doesn't look like this, replace the tag and correct the discrepancy.
